Pool Inspection Report

123 Sample Dr.

Inspector: Bryan Miller

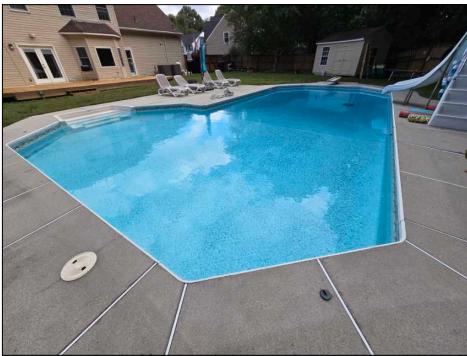
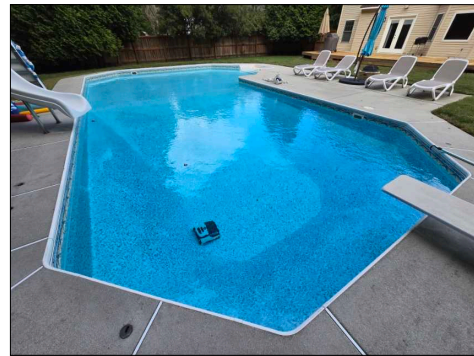
2.1. Fading of the liner was indicative of chemical damage or age. We recommend asking seller when the liner was installed. Typical life expectancy of a vinyl pool liner is 7-12 years.

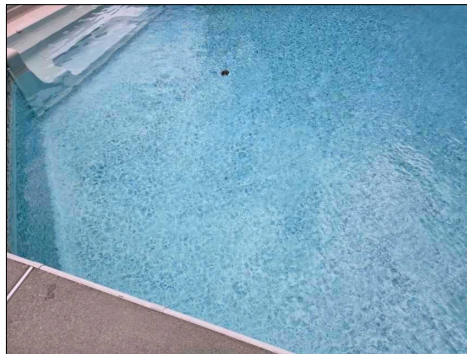
Faded vinyl liner

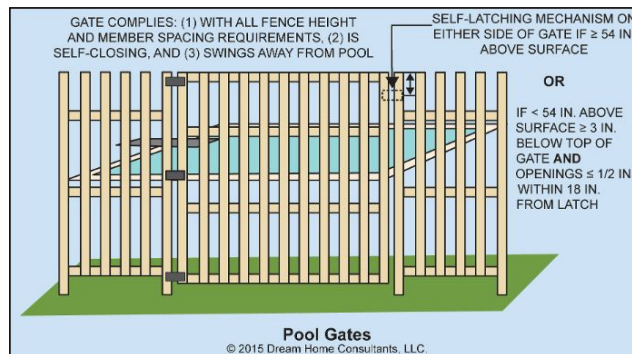
3.1. The gate was not self-closing, which is a safety concern, and should be corrected safety.

3.2. The pool gate swings in toward the pool which is a safety concern and should be corrected.

Pool gate information

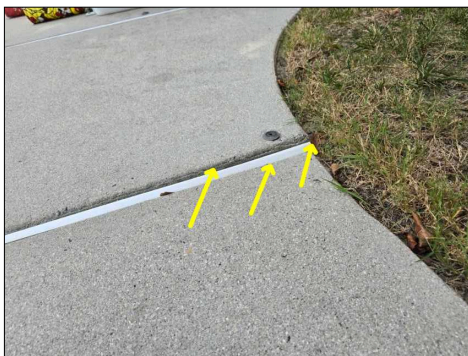
4.2. There was settlement observed at the pool deck. We cannot determine cause of the settlement. We recommend discussing with sellers to determine how long it has been present, and if it has caused issues. A qualified contractor should be consulted to determine the best method to cure.

4.3. There was uneven decking that had created trip hazards. Location: near sliding board

Trip hazard/settlement

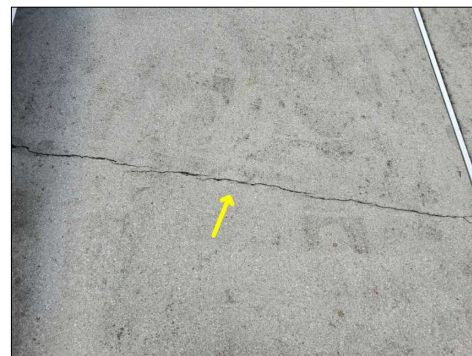
4.1. There was cracking observed at the pool deck. We recommend sealing to prevent further damage during freeze/thaw cycles.

Deck cracking

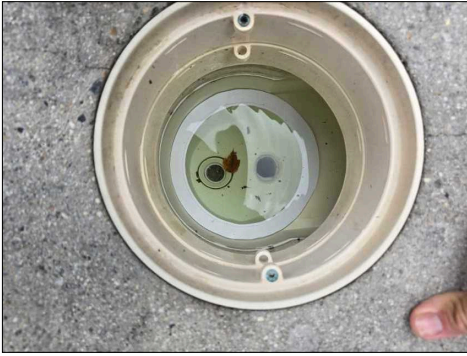
No issues observed- deep

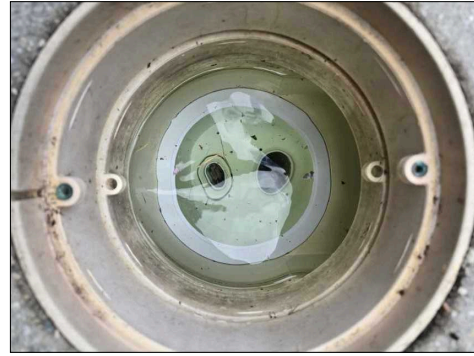
No issues observed- shallow

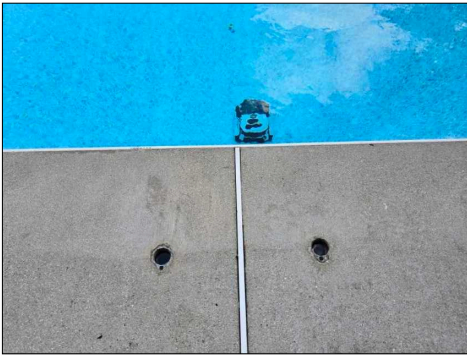
6.1. The pool ladder and anchor bolts were missing and should be installed for safety.

Missing ladder

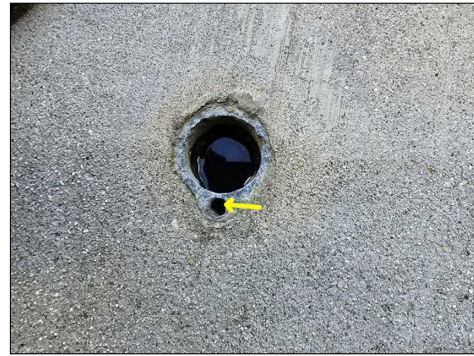
Missing anchor bolts

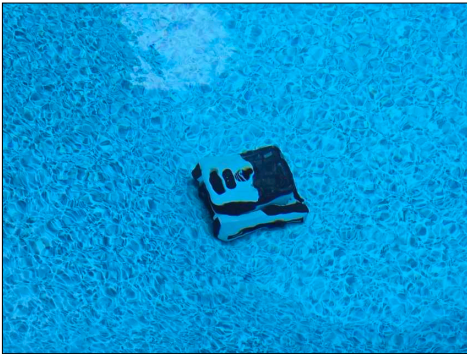
7.1. A pool cleaner was observed, but not in use. We recommend asking seller if it is functional and proper operation of system.

Cleaner present - not tested- robot

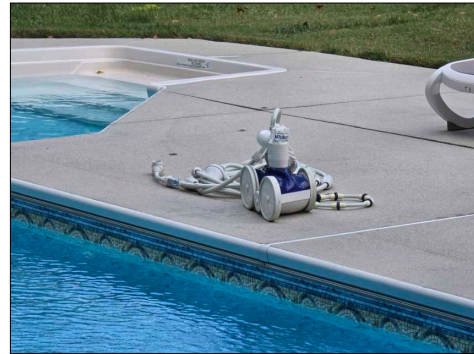
Cleaner present - not tested- pressure side cleaner

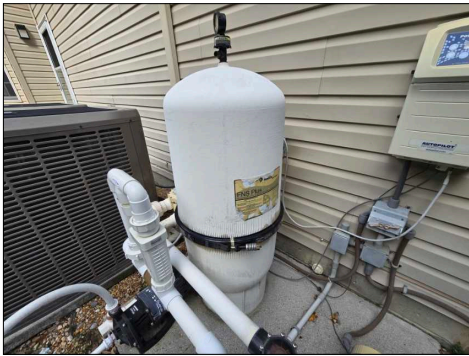
The pool filter was a diatomaceous earth (DE) filter. Ideal pressure 10-20 psi, but each pool is a little different. As the filter becomes dirty the pressure will increase. Generally an increase in pressure of 5-10 psi indicates a need to clean the filter. The DE grids have a typical life expectancy of 3-5 years. You should inquire about the service history of the grids.

8.3. The pool filter appeared to be older equipment. We can never predict the exact time of failure with regard to any component. Although the system was functioning we recommend budgeting for replacement.

DE Filter

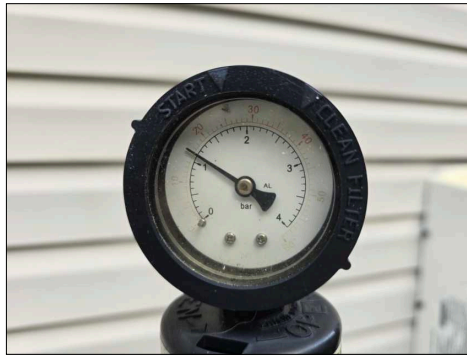
Pressure gauge functional

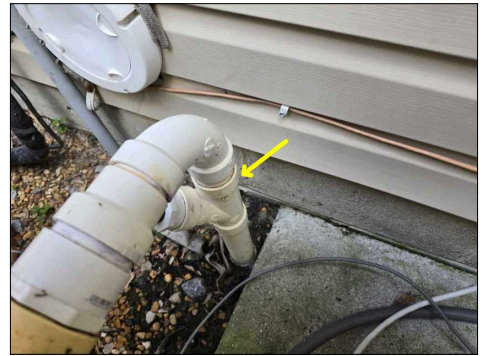
8.2. The backwash discharge location was not observed. Recommend consulting with seller to determine location.

Backwash location not observed

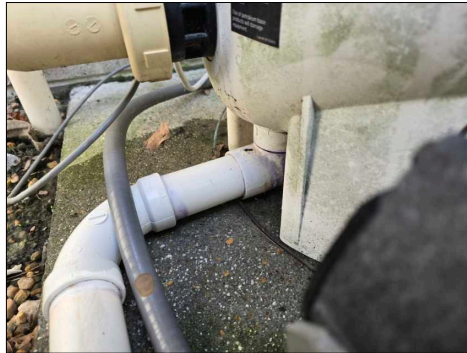
8.1. There was evidence of prior leaking. Recommend consulting with seller to determine when system was last serviced.

Evidence of leaking

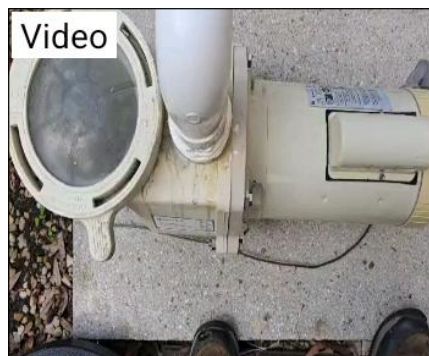
9.1. The pumps were run for at least 10 minutes. The pumps are not evaluated for capacity, efficiency, flow rate or pressure. We do not pressure test this system for leaks. You can have the entire system pressure checked for leaks if concerned.

Functional

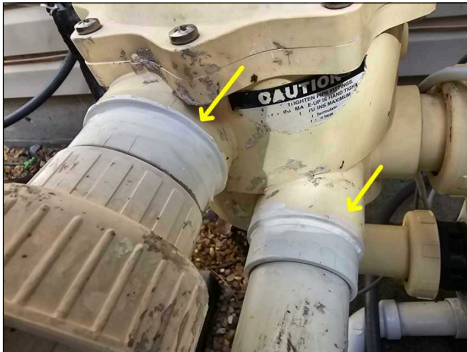
10.1. Repairs were observed at the piping. We cannot determine how effective they will be long term. You should have evaluated by a qualified contractor. Location: multiport valve and pump MTA

Previous repairs

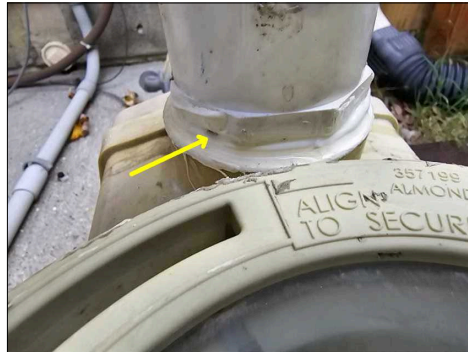
10.2. Active leaks were observed. We recommend evaluation of the system by a pool specialist to repair as needed. Location: pump pressure side MTA

Leaking fitting

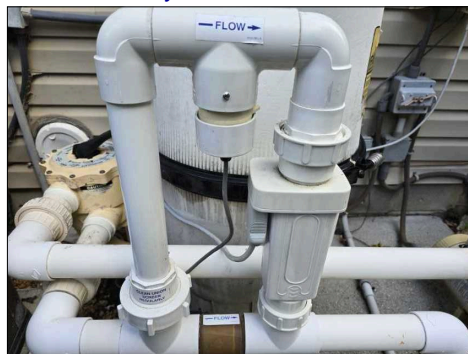
11.1. A salt cell was present. These typically have a life expectancy of 3-5 years, and require cleaning. Recommend asking seller the age of the cell and the service history.

Salt cell

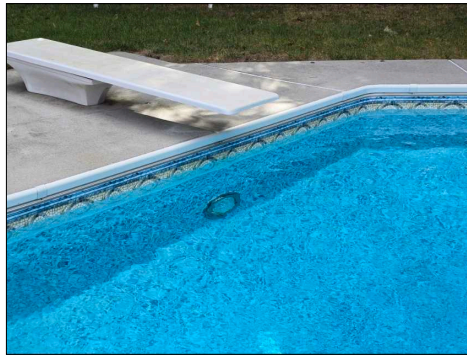
13.1. The pool light did not function and should be repaired as needed.

Did not function

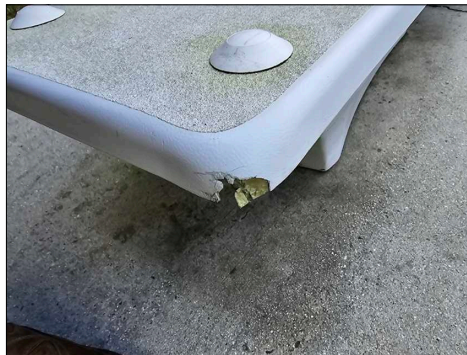
14.3. There was damage noted at the diving board that should be repaired or replaced if the board is to be used.

Minor damage
